School District No. 40 (New Westminster)

Building Assessment Study Massey Theatre

735 – 8th Avenue, New Westminster B.C.

SEPTEMBER 2009

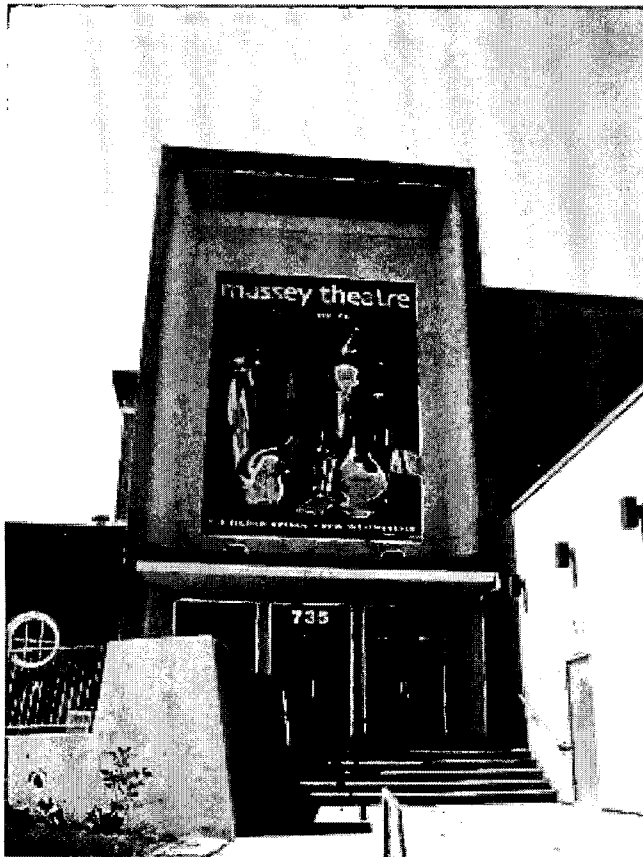
Photo 1: East Entry to Massey Theatre
Description: East end of three storey lobby, concession and office area.
Issue: Moment frame to be provided to restrain east end of block.

- f) At the east and west ends of the block, provide steel moment frames from foundation to roof level to restrain the existing stair well and the entry to the lobby.
- g) In the north-south direction and the east-west direction, provide 12mm plywood sheathing to existing wood stud walls and block at the second and third floor levels. Provide new parallam beams and columns to support the new plywood shear walls in the north-south direction. At the ground floor level, provide 12mm plywood sheathing to existing wood stud walls and block; extend walls to the existing foundation walls. Upgrade connections to the existing foundation wall.

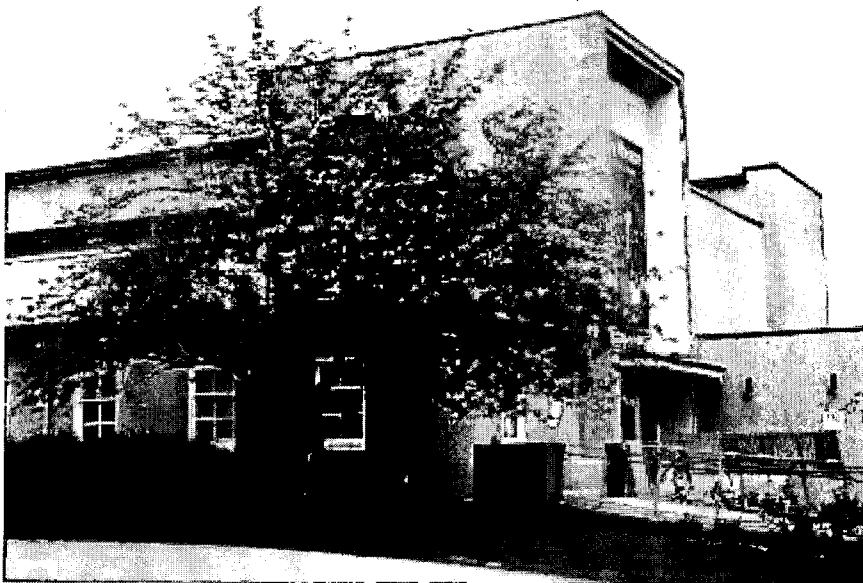
Photo 2: South East View of Theatre
Description: Single storey Plaskett Gallery, lobby, concession and office space and auditorium and fly tower visible. Band room to the lower right hand side of the photo.

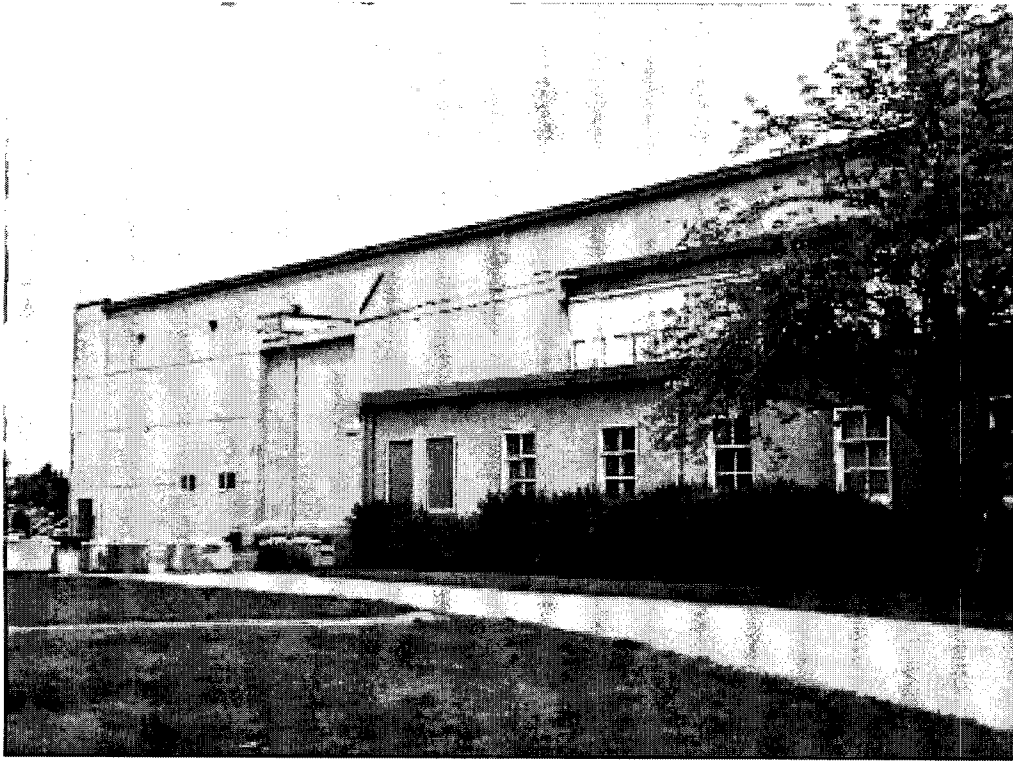
Photo 3: South View of Theatre)

Description: Plaskett Gallery, lobby, concession, offices and auditorium visible.

Issue: Gymnasium to the west of the auditorium to be removed. (Gymnasium located on the left hand side of the photo)

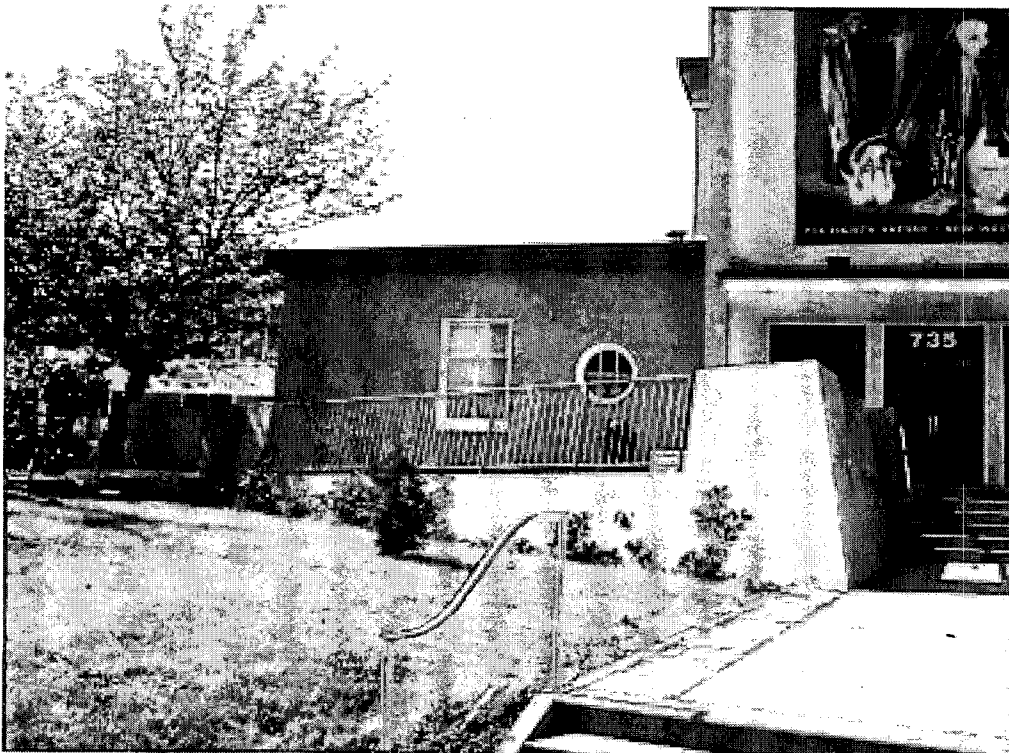
Photo 4: East View of Plaskett Gallery

Description: Single storey over crawl space Plaskett Gallery.

Issue: New plywood shear walls to east wall of Gallery required.

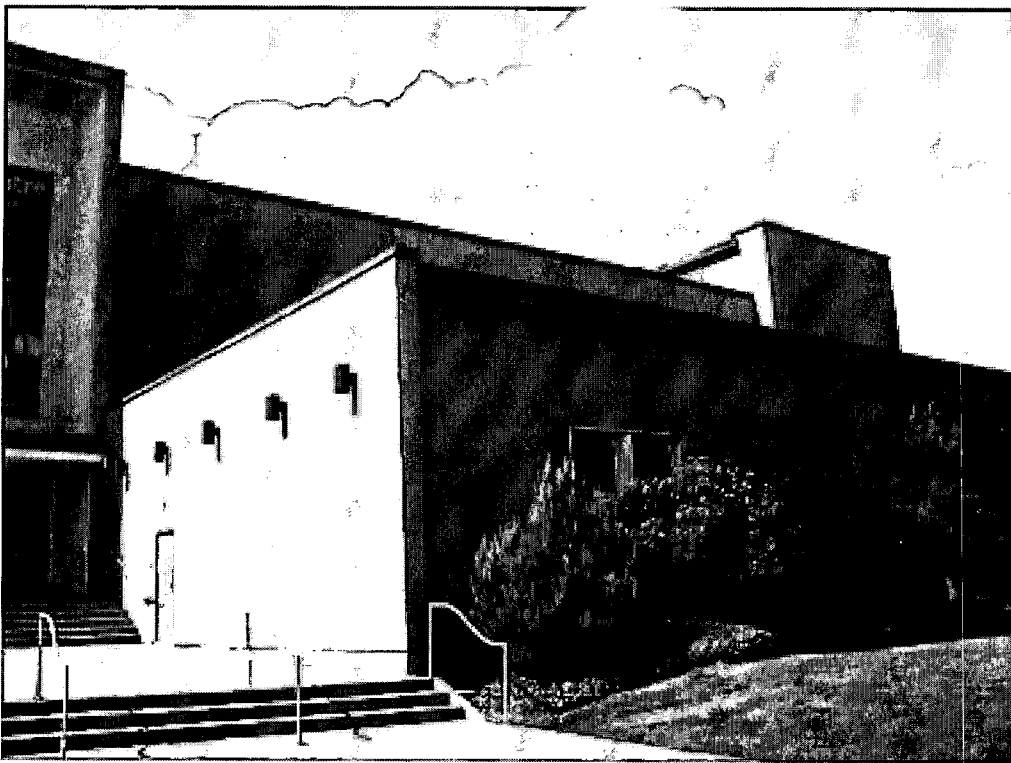
Photo 5: East View of Theatre .

Description: Band room to the east of the structure with auditorium and fly tower in the background.

Issue: Band room to be removed and is not included in review.

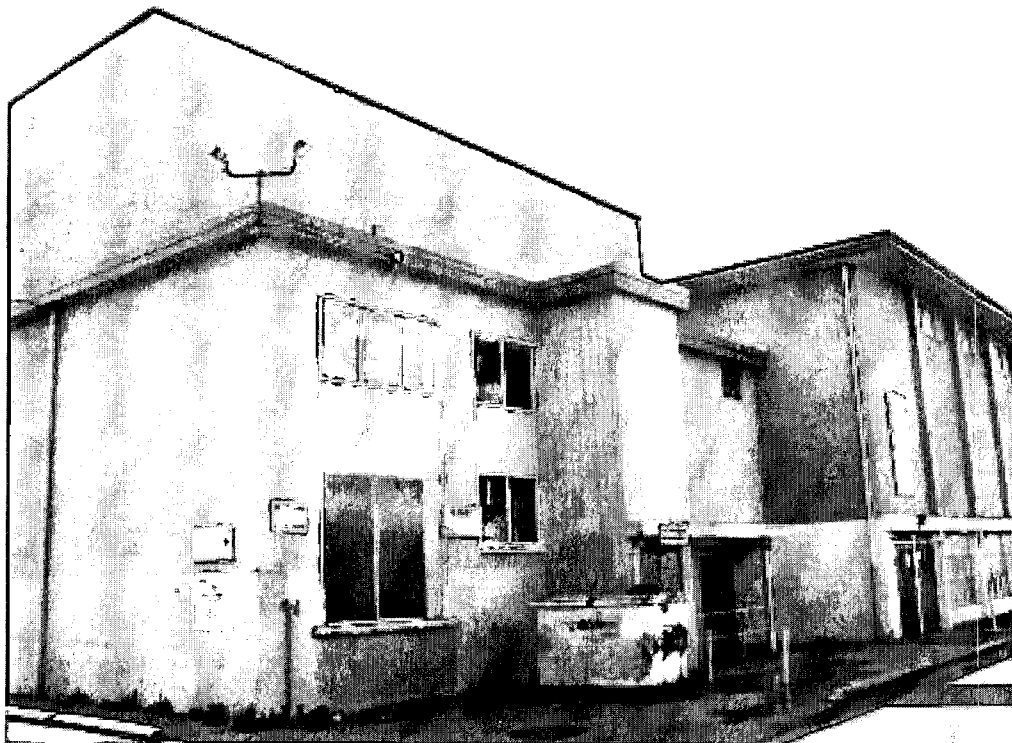
Photo 6: North East View of Theatre

Description: Shows storage, dressing rooms and washrooms to the north east of the stage area

Issue: Small gymnasium past block to be removed and was not reviewed.

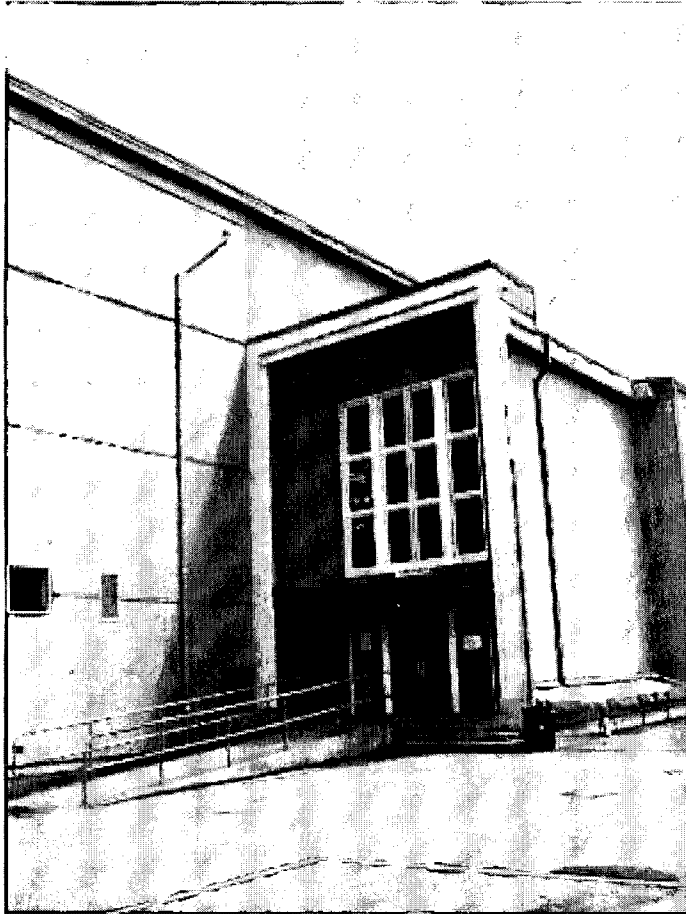
Photo 7: West View of Lobby
Description: West entry to lobby.
Issue: End of wall to be restrained by moment frame.

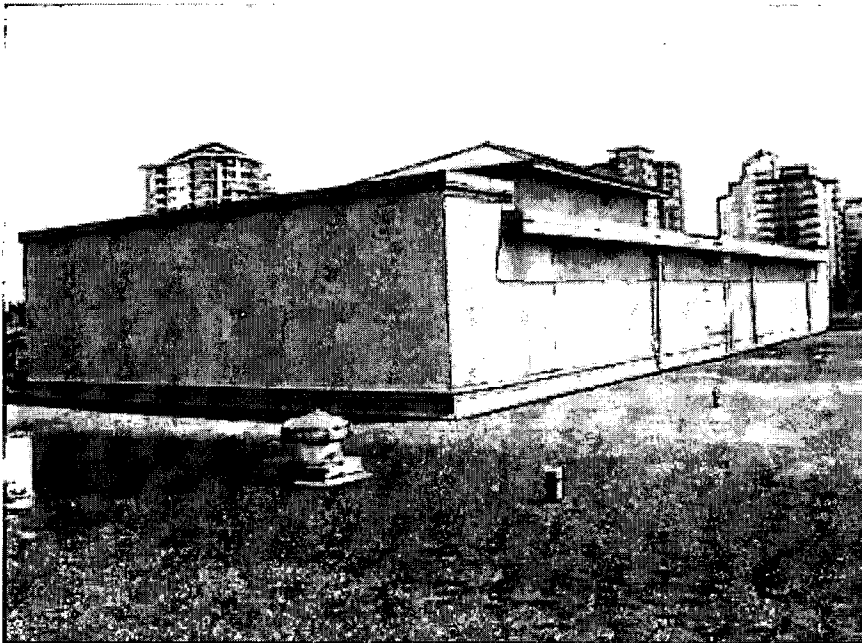
The existing timber roof, floors, and walls as well as the load-bearing concrete and timber columns, and the infill masonry walls appear to be performing as intended for the loads presently imposed and imposed over the past years. There are no signs of structural distress including fire or sagging floors or cracking of the exterior stucco finish and interior sheathing. The timber trusses, joists, and studs are exposed in the attic space and this timber appears to be in good condition. The last re-roofing of the building was in the early 1990s (see photo 8).

Photo 8: Auditorium Roof
Description: Existing roof including view of fly tower extending past auditorium roof.
Issue: New steel plate and plywood diaphragms to be provided at roof level.

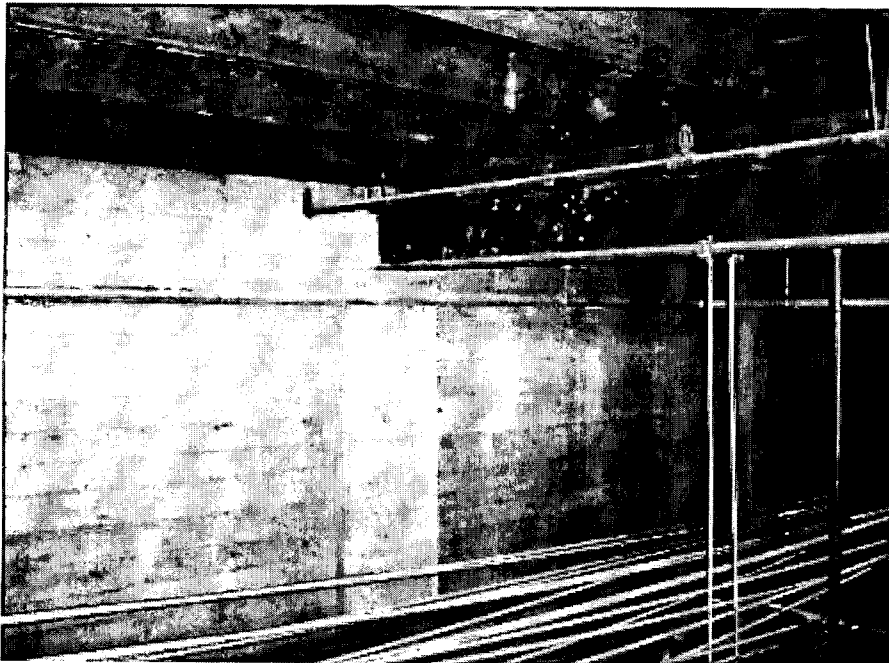
Photo 10: Fly Tower Roof Space

The Theatre fly tower structure is comprised of roofing over shiplap spanning to 3"x 8" wood joists at 400mm on centre supported by steel wide flange beams spanning in the north-south direction supported by 200mm reinforced concrete walls with 100mm x 400mm wide pilasters at beam locations (see photo 10). Concrete walls extend to foundation level and are supported by concrete foundation walls. The stage is wood construction.

Description: Fly tower roof deck supported by wood joists, steel beams and reinforced concrete walls

Issue: Non compliant roof diaphragm and existing concrete walls to be upgraded.

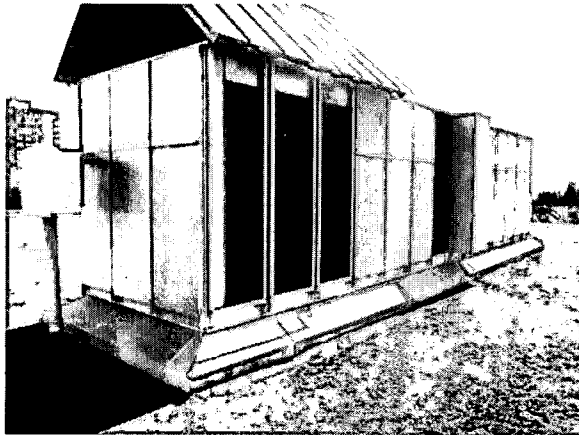
Theatre HVAC Unit, which should be replaced

- The Theatre rooftop AHU should be replaced. At 35 years old it is past its period of expected useful service life. The replacement unit will provide 25,000 cubic feet per minute (CFM) of airflow and have a rated cooling capacity of 60 tons. Existing ductwork, located in the attic, can be kept in use but should be cleaned. Since the existing AHU is a multi-zone, which provides separate supply ducts to four zones, an alternative is to provide four separate new AHU's, although this would increase maintenance requirements.

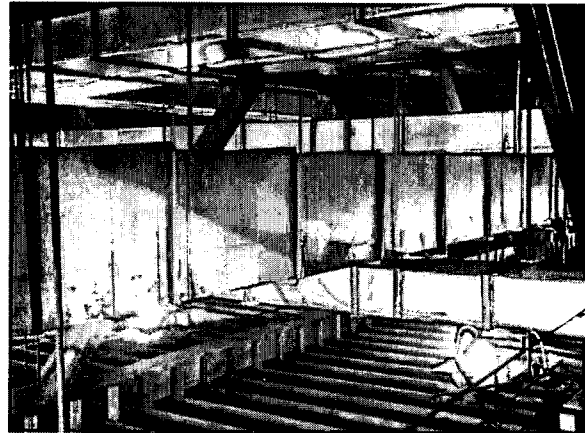
Supply air ductwork in the Theatre attic, which can be kept in service as part of a facility upgrade

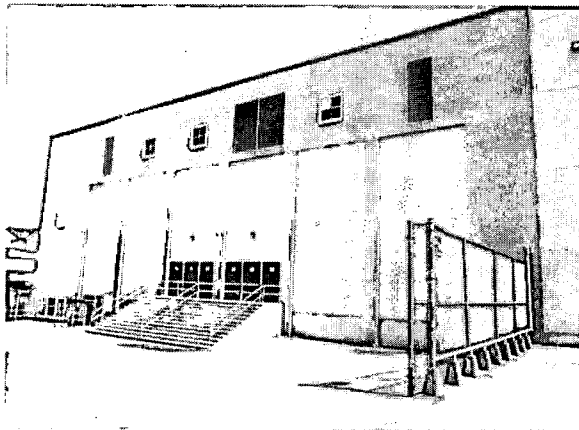
Intake and relief air louvers serving the Hyack (large) Gymnasium. The large AHU serving the Gym is inside the attic

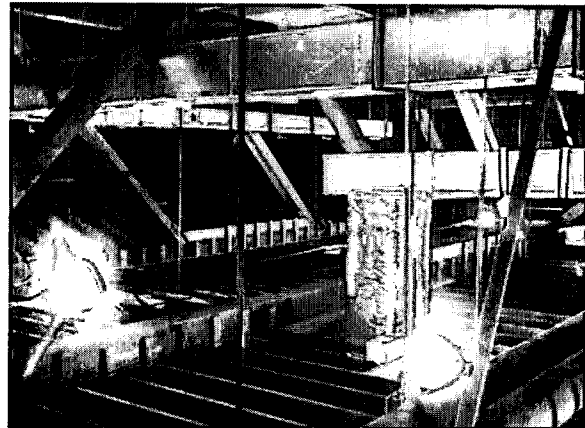
Supply air ductwork in the Hyack Gym attic.

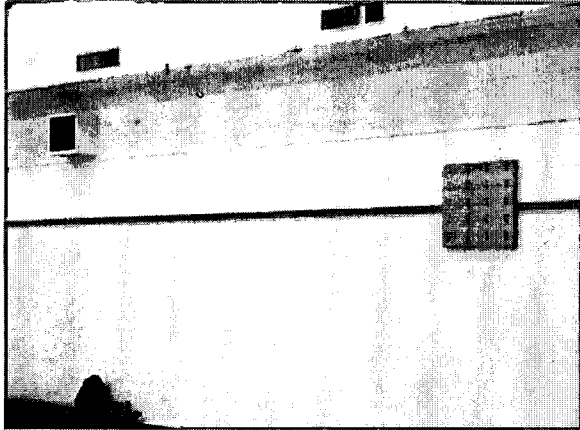
- The Small Gymnasium is served by an AHU located in a roof access fan room, which is undersized in terms of airflow capacity and in very poor condition. It has recently been put back into service due to indoor air quality concerns but has been out of service for a number of years prior due to its poor condition.

Supply ventilation grilles in the Small Gymnasium

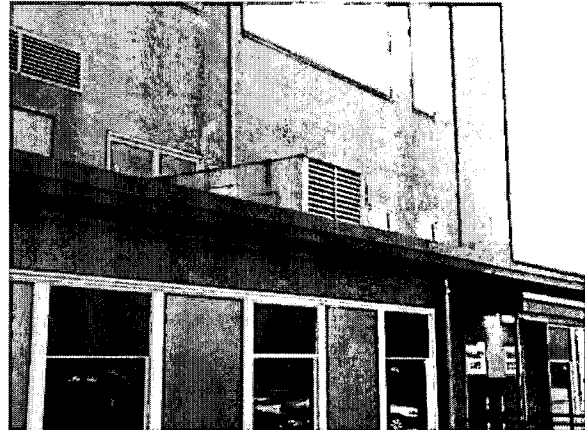
- The Cafeteria is served by a packaged rooftop unit that is in poor condition
- The Massey Office is served by a packaged rooftop unit installed approximately five years ago, that is in good condition.

Cafeteria packaged rooftop unit

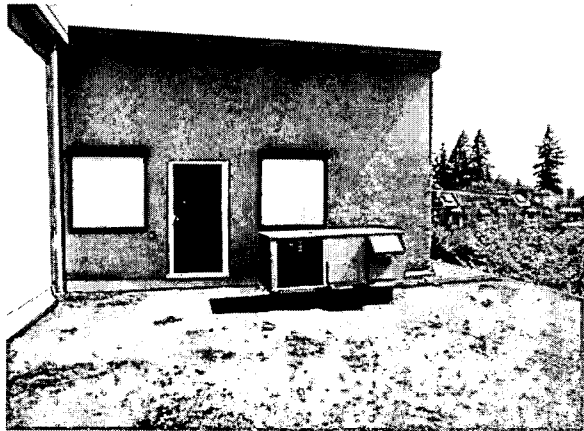
Massey Offices packaged rooftop unit, installed approximately 2004, and in good condition

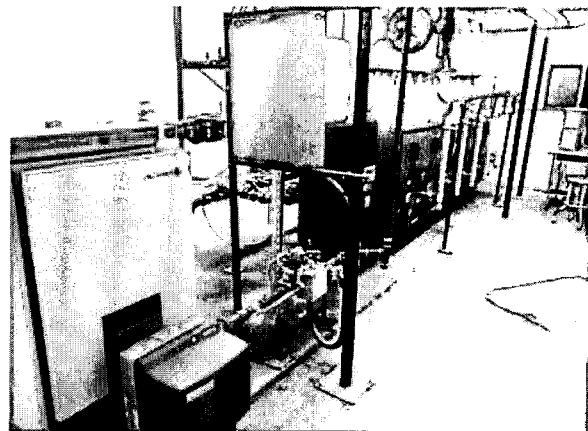
Heating boiler plant. In the foreground is the newer De Dietrich cast iron boiler with power burner and in the background the older Hydrotherm atmospheric boilers

- The Theatre smoke removal system fans should be replaced, and interfaced with the fire alarm system. Smoke removal capacity should be 25,000 CFM.
- The inefficient Hydrotherm atmospheric boilers should be replaced. The recommended approach to upgrading the plant would utilize condensing boiler technology that will contribute to around 90-percent efficiency over the course of each annual heating cycle, improving operating efficiency and reducing greenhouse gas emissions. The plant will consist of a combination of condensing and traditional high temperature appliances, with an operating strategy utilizing the condensing boilers when possible, and firing the high temperature boiler only when absolutely necessary, during colder weather. Approximately 600,000 BTU per hour capacity condensing boilers will be required. The existing De Dietrich cast iron boiler can be kept in use as the high temperature boiler.

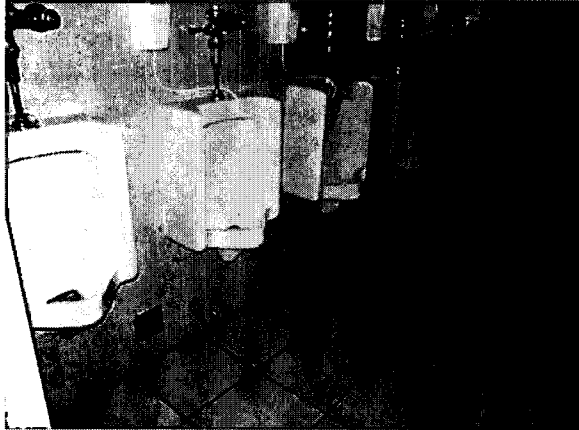
Wall mounted flush valve urinals are relatively new and in good condition

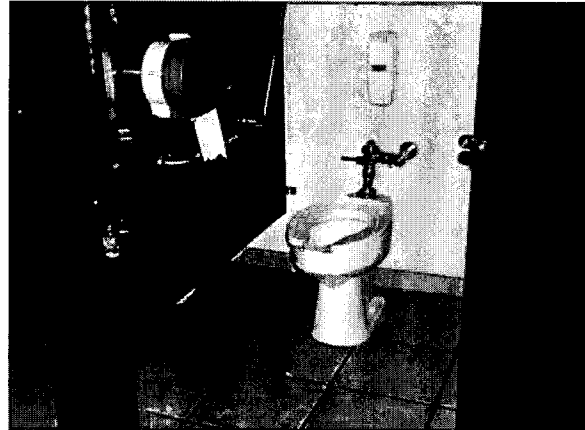
Floor mounted flush valve toilets are relatively new and in good condition

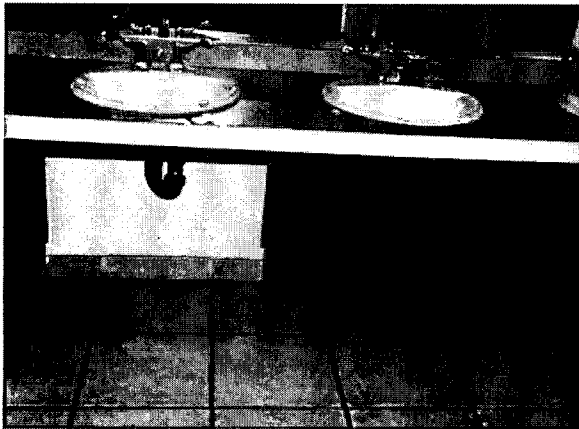
Vanity mounted sinks are relatively new and in good condition. The sink on the left is handicapped accessible.

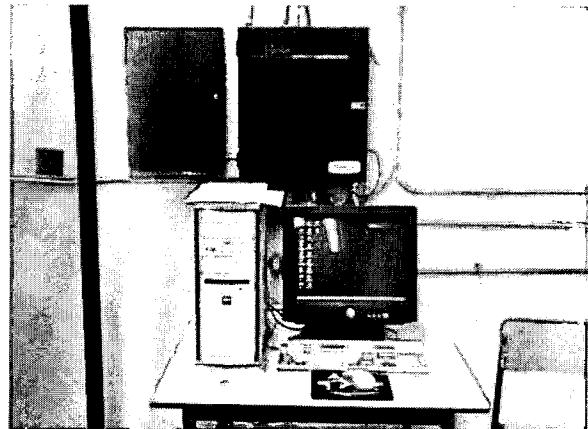
Digital controls workstation in the boiler room. Barber Colman system in place for the boiler plant, but not the balance of HVAC equipment in the building
