**REPORT ON**

**PHASE I ENVIRONMENTAL SITE ASSESSMENT  
220 ROYAL AVENUE  
NEW WESTMINSTER, BRITISH COLUMBIA**

March 2, 2004

04-1412-036

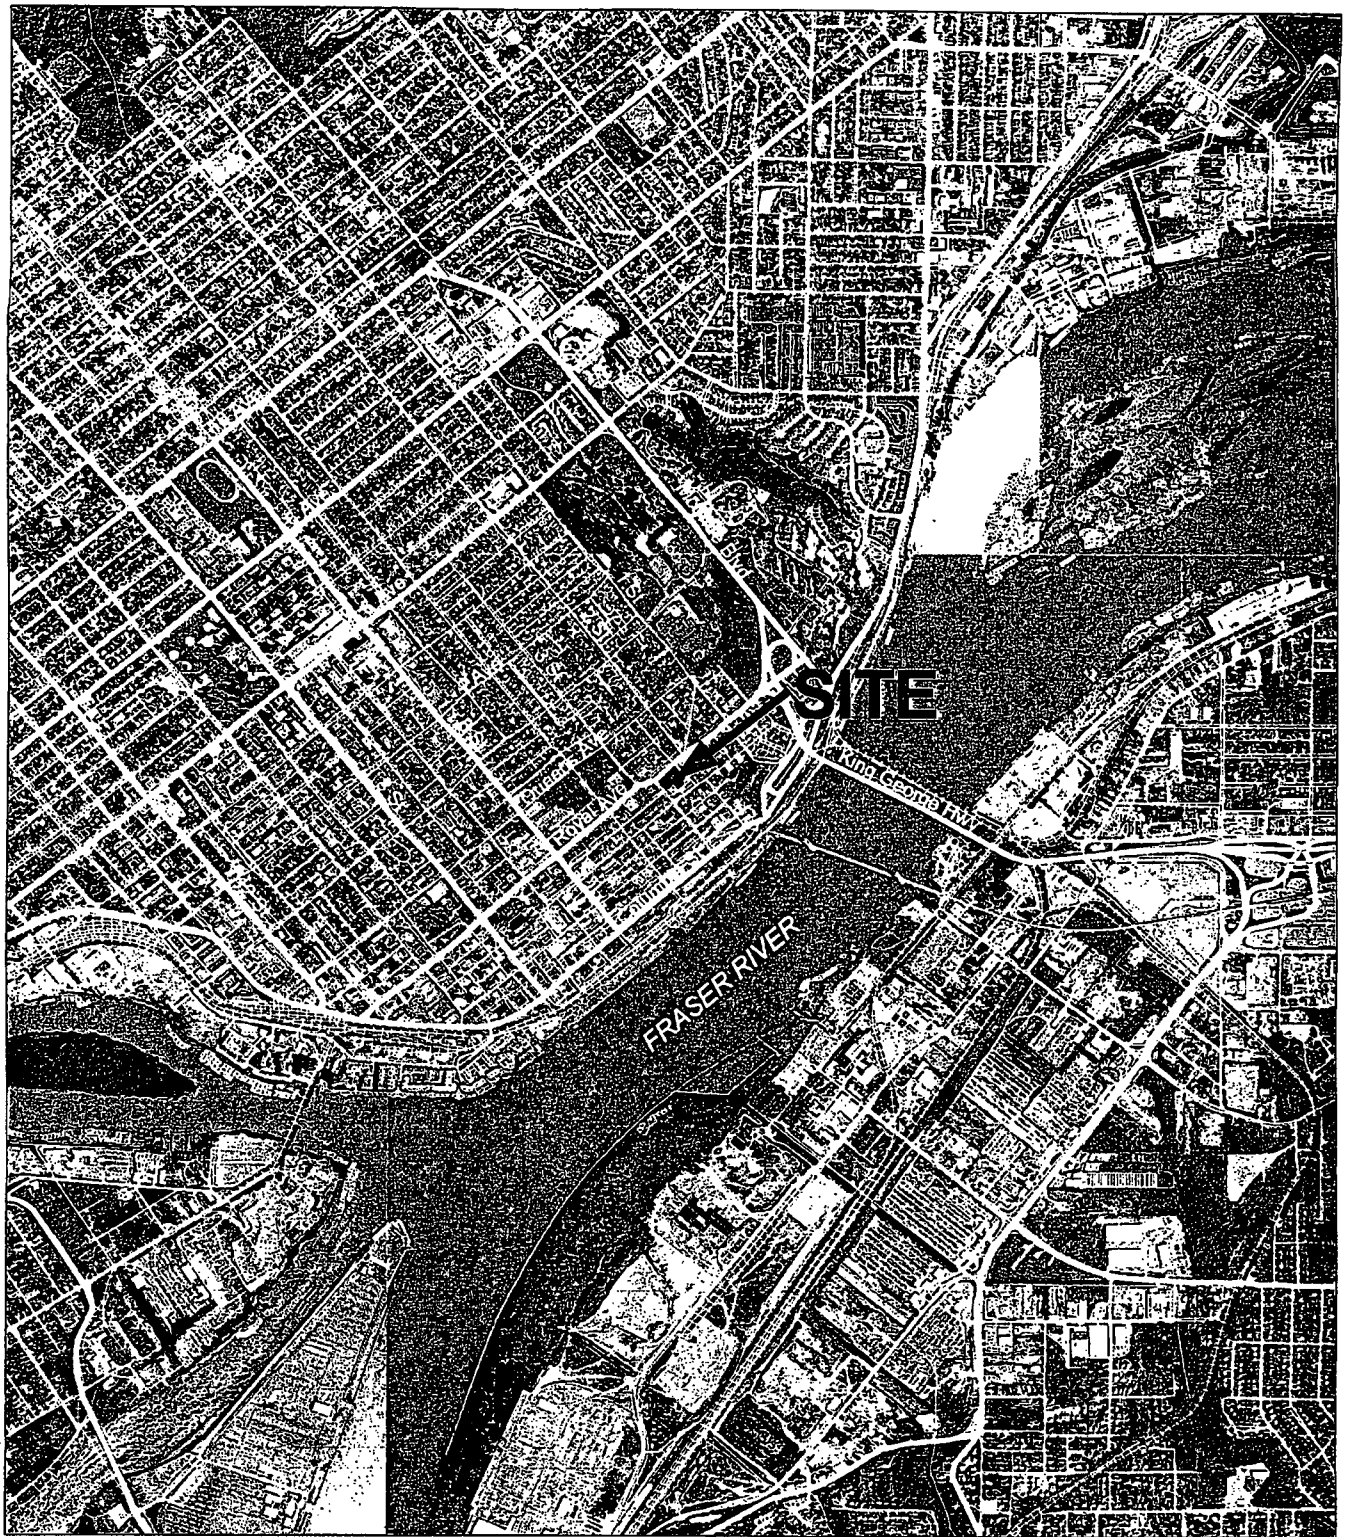
**REFERENCE**

Source: Triathlon (1995 Orthophotos), DMTI Spatial  
Datum: NAD 83 Projection: UTM Zone 10

Golder Associates Burnaby, B.C.	PROJECT No.	04-1412-036	SCALE AS SHOWN
	DESIGN	HS 18 Feb. 2004	<b>FIGURE 1</b>
	GIS	GDH 18 Feb. 2004	
	CHECK	HS 18 Feb. 2004	
	REVIEW		
REV. 0

Figure 1	Key Plan
Figure 2	Site Plan
Figure 3	Existing Hospital Building
Figure 4	Former Hospital Building
